~~CONFIDENTIAL~~  
**BUREAU OF SHIPS GROUP**  
**TECHNICAL INSPECTION REPORT**  
~~CONFIDENTIAL~~

**6 OPERATION CROSSROADS.**  
**U.S.S. BRULE (APA 66).**

**TEST ABLE [U].**

BUREAU OF SHIPS GROUP  
TECHNICAL INSPECTION REPORT

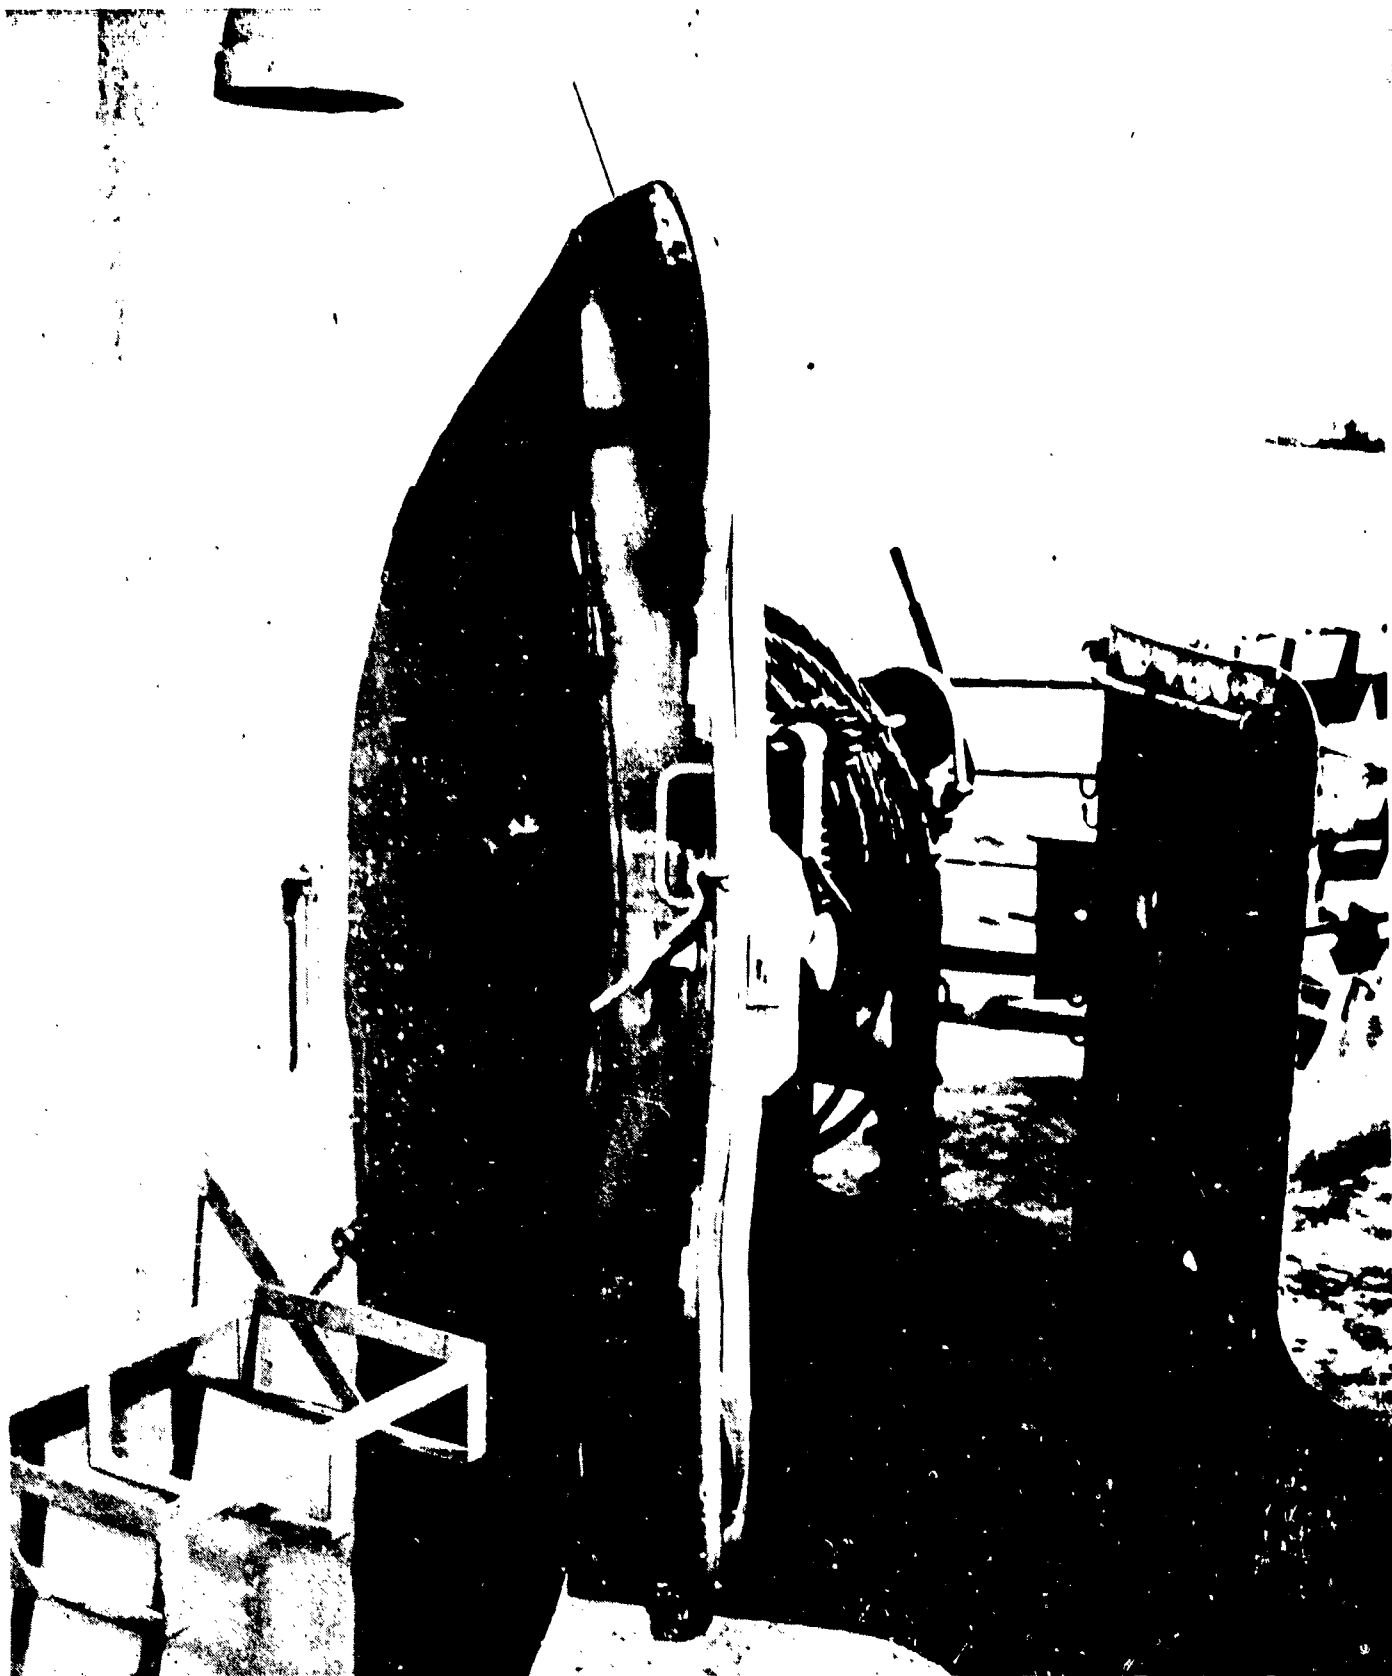
AA-CR-65-1819-10. Damaged door and broken door hook, upper deck, frame 27, port.

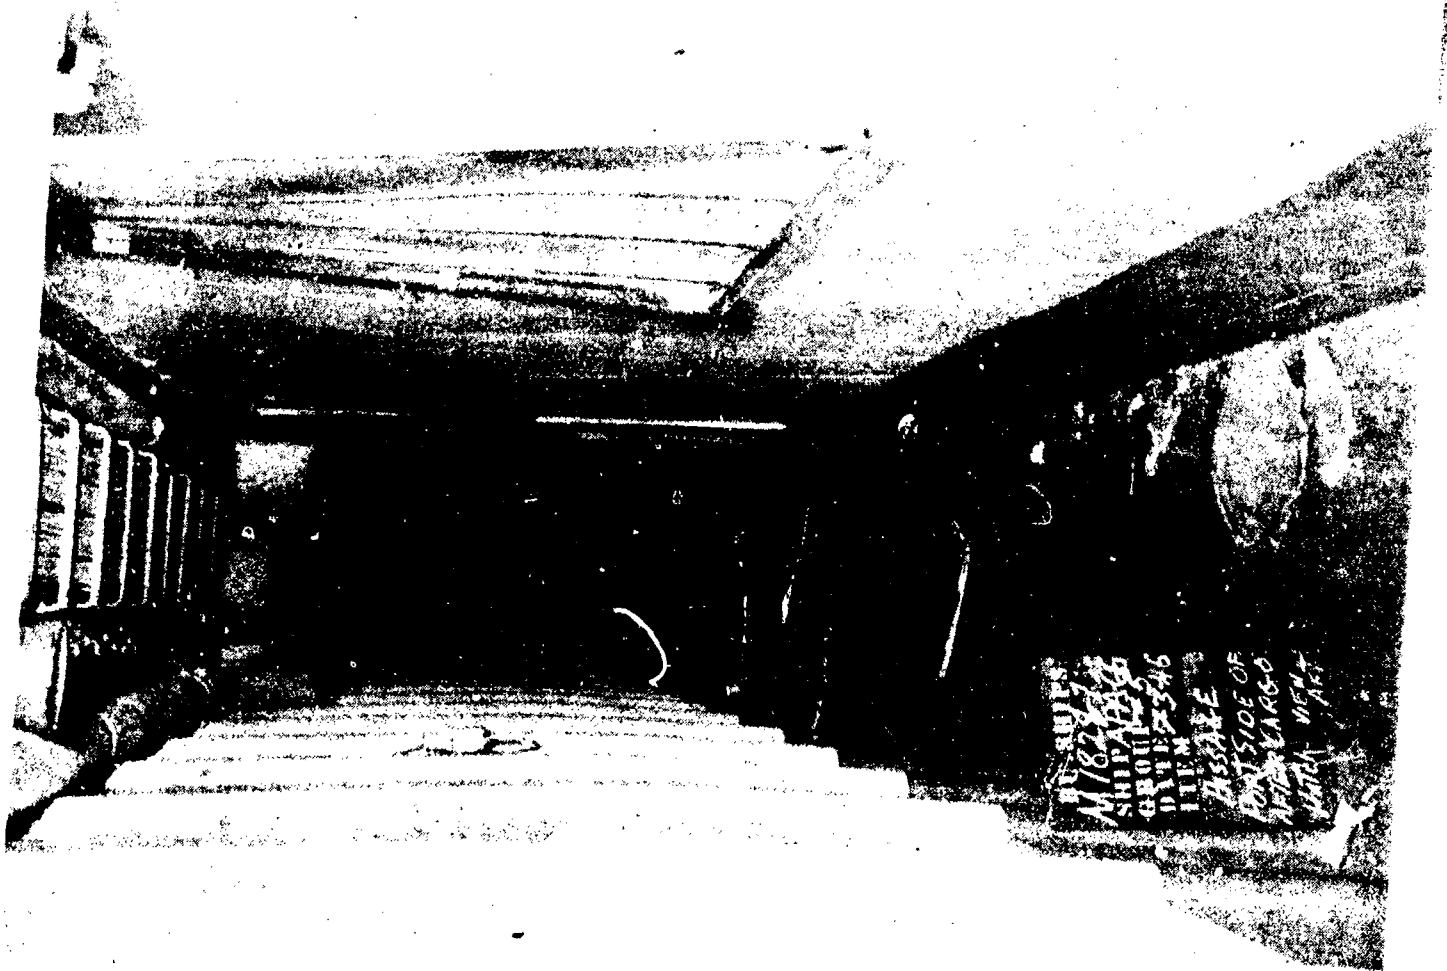
AA-CR-82-1828-1. Looking aft in passageway, main deck, port, adjacent cargo hatch 2. Showing deflection of light structural bulkhead and damage to metal joiner bulkhead.

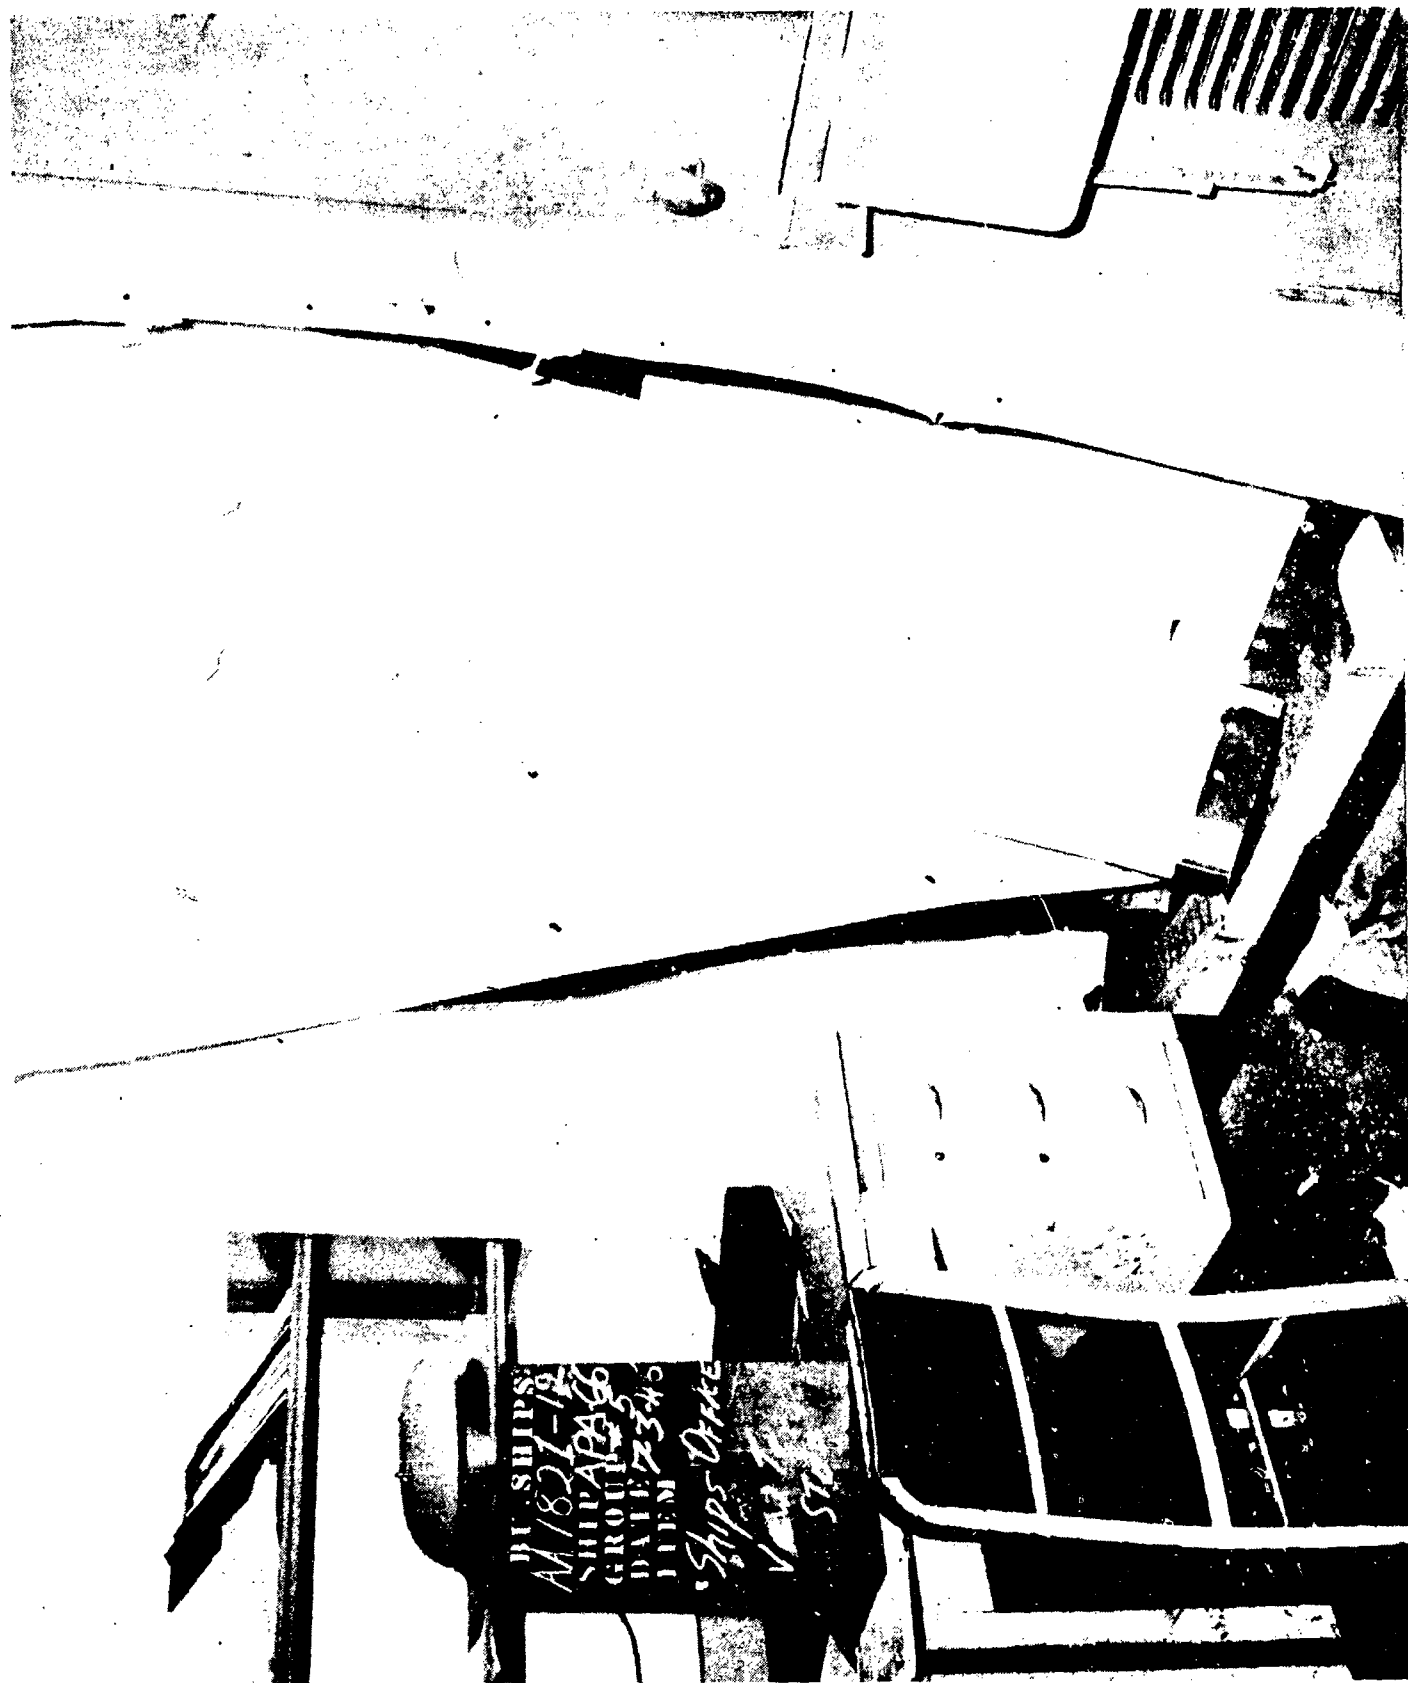
AA-CR-82-1827-12. Ship's office, main deck, frame 98, port, looking forward and to starboard. Blast damage to metal joiner bulkhead.

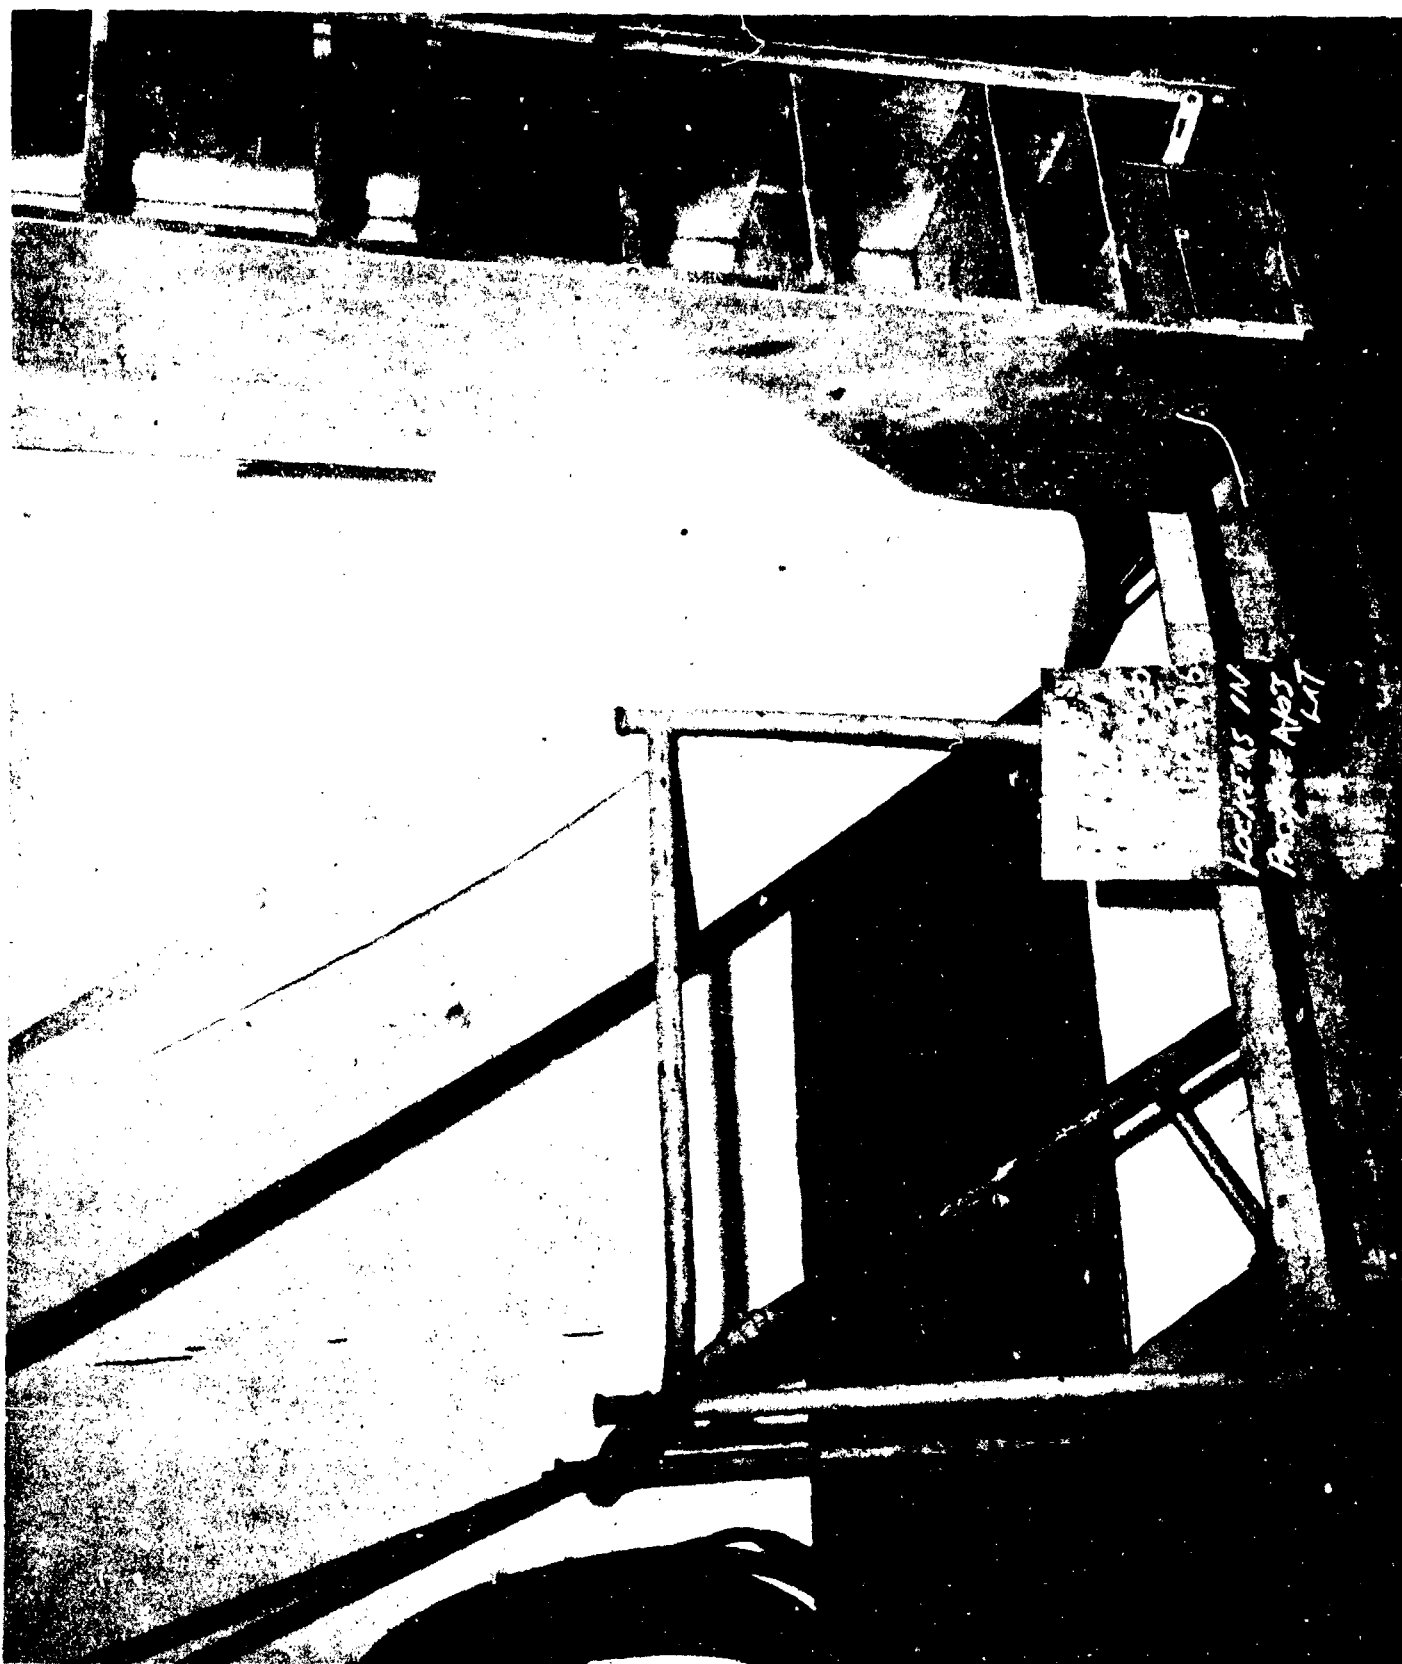
AA-CR-82-1827-11. Passage A-102LAT. Blast damage to lockers and apron under ladder. Lockers were displaced from foundation.

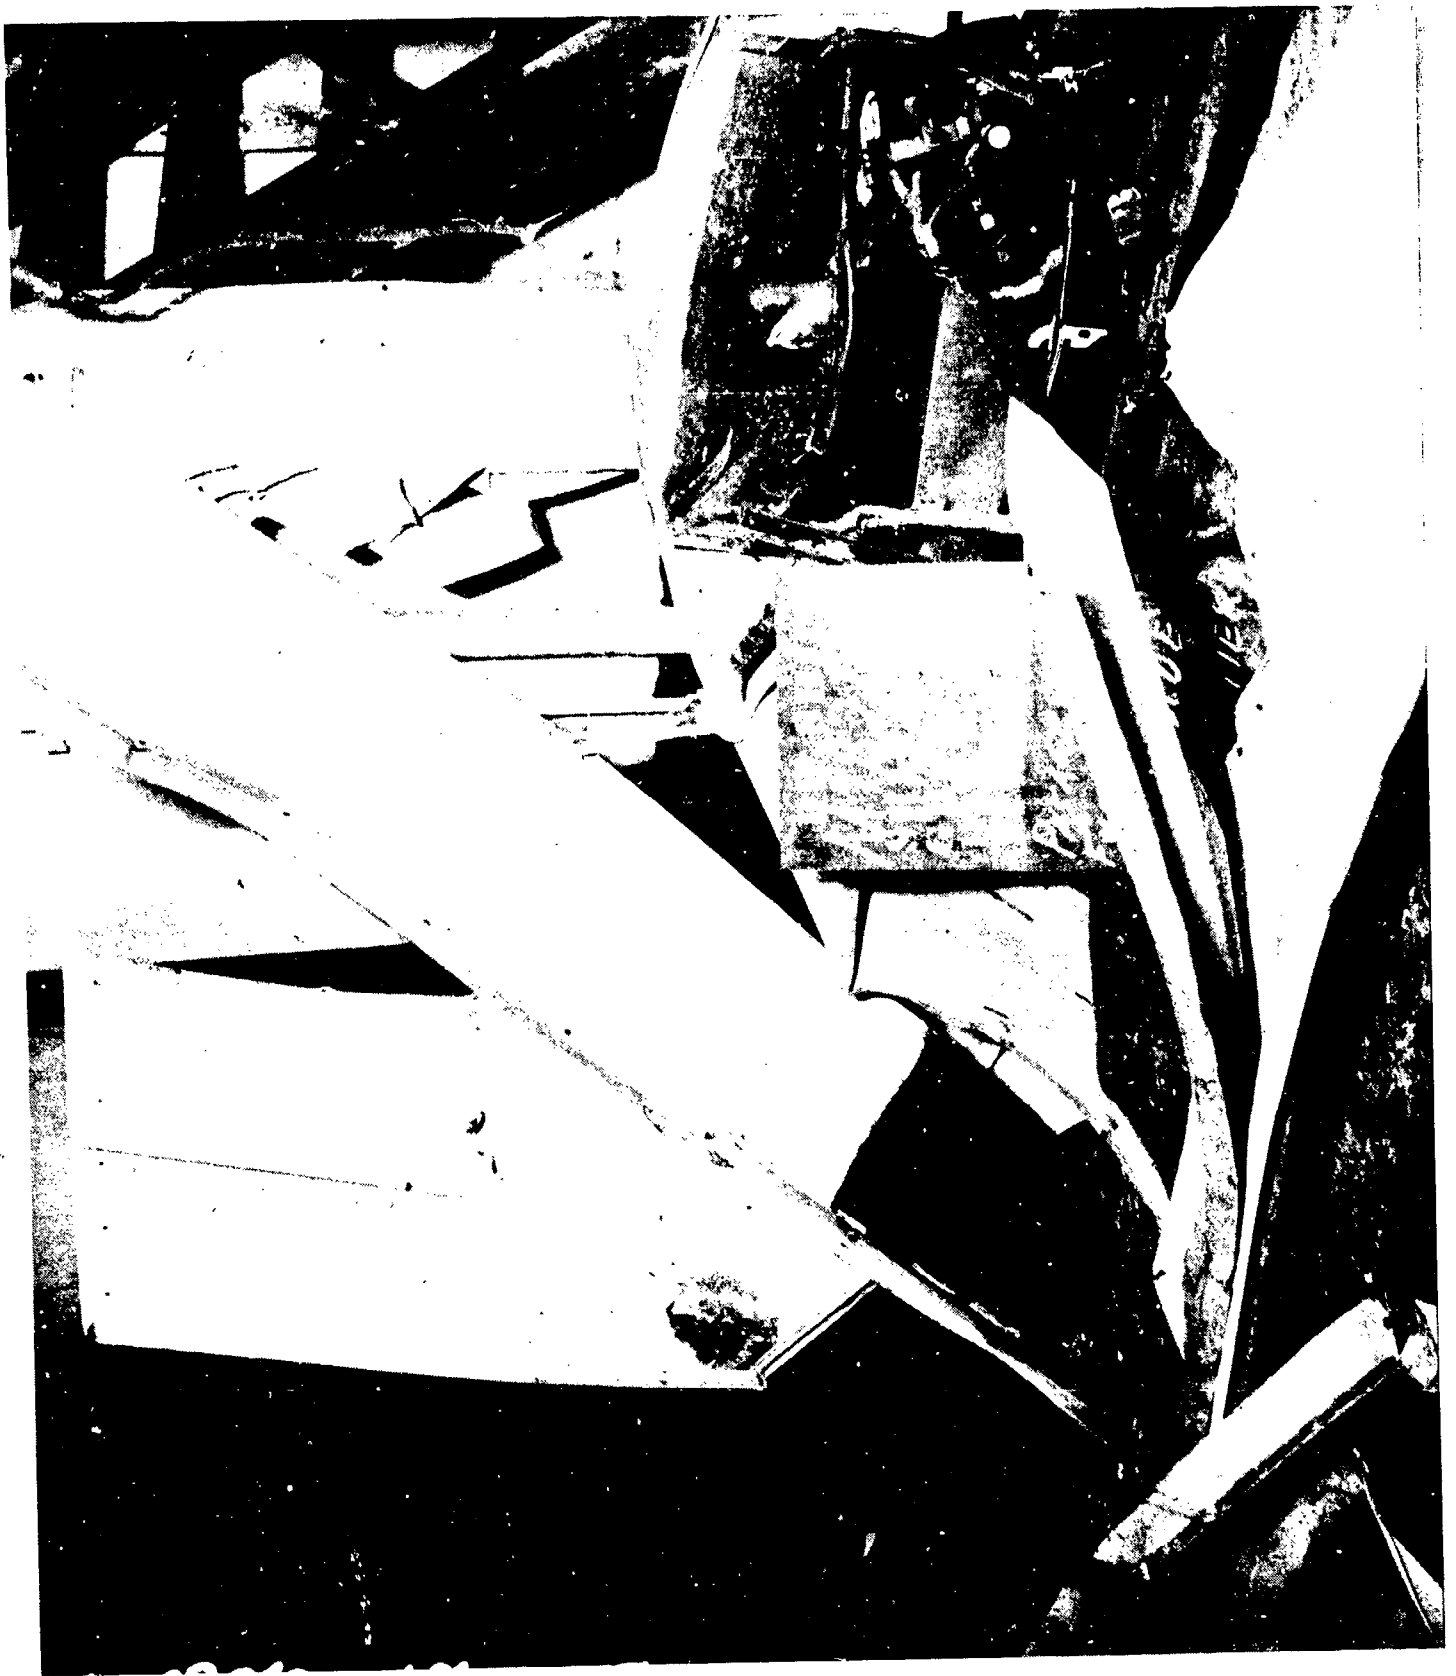
The two starboard boat davit controllers and a dishwasher controller were inoperable due to broken insulating panels.

AA-CR-82-1827-5. Main deck, frame 68, starboard. Damage to metal joiner bulkhead around ladder 1-68-1. Note damage to electric controller for dish washer secured to bulkhead.

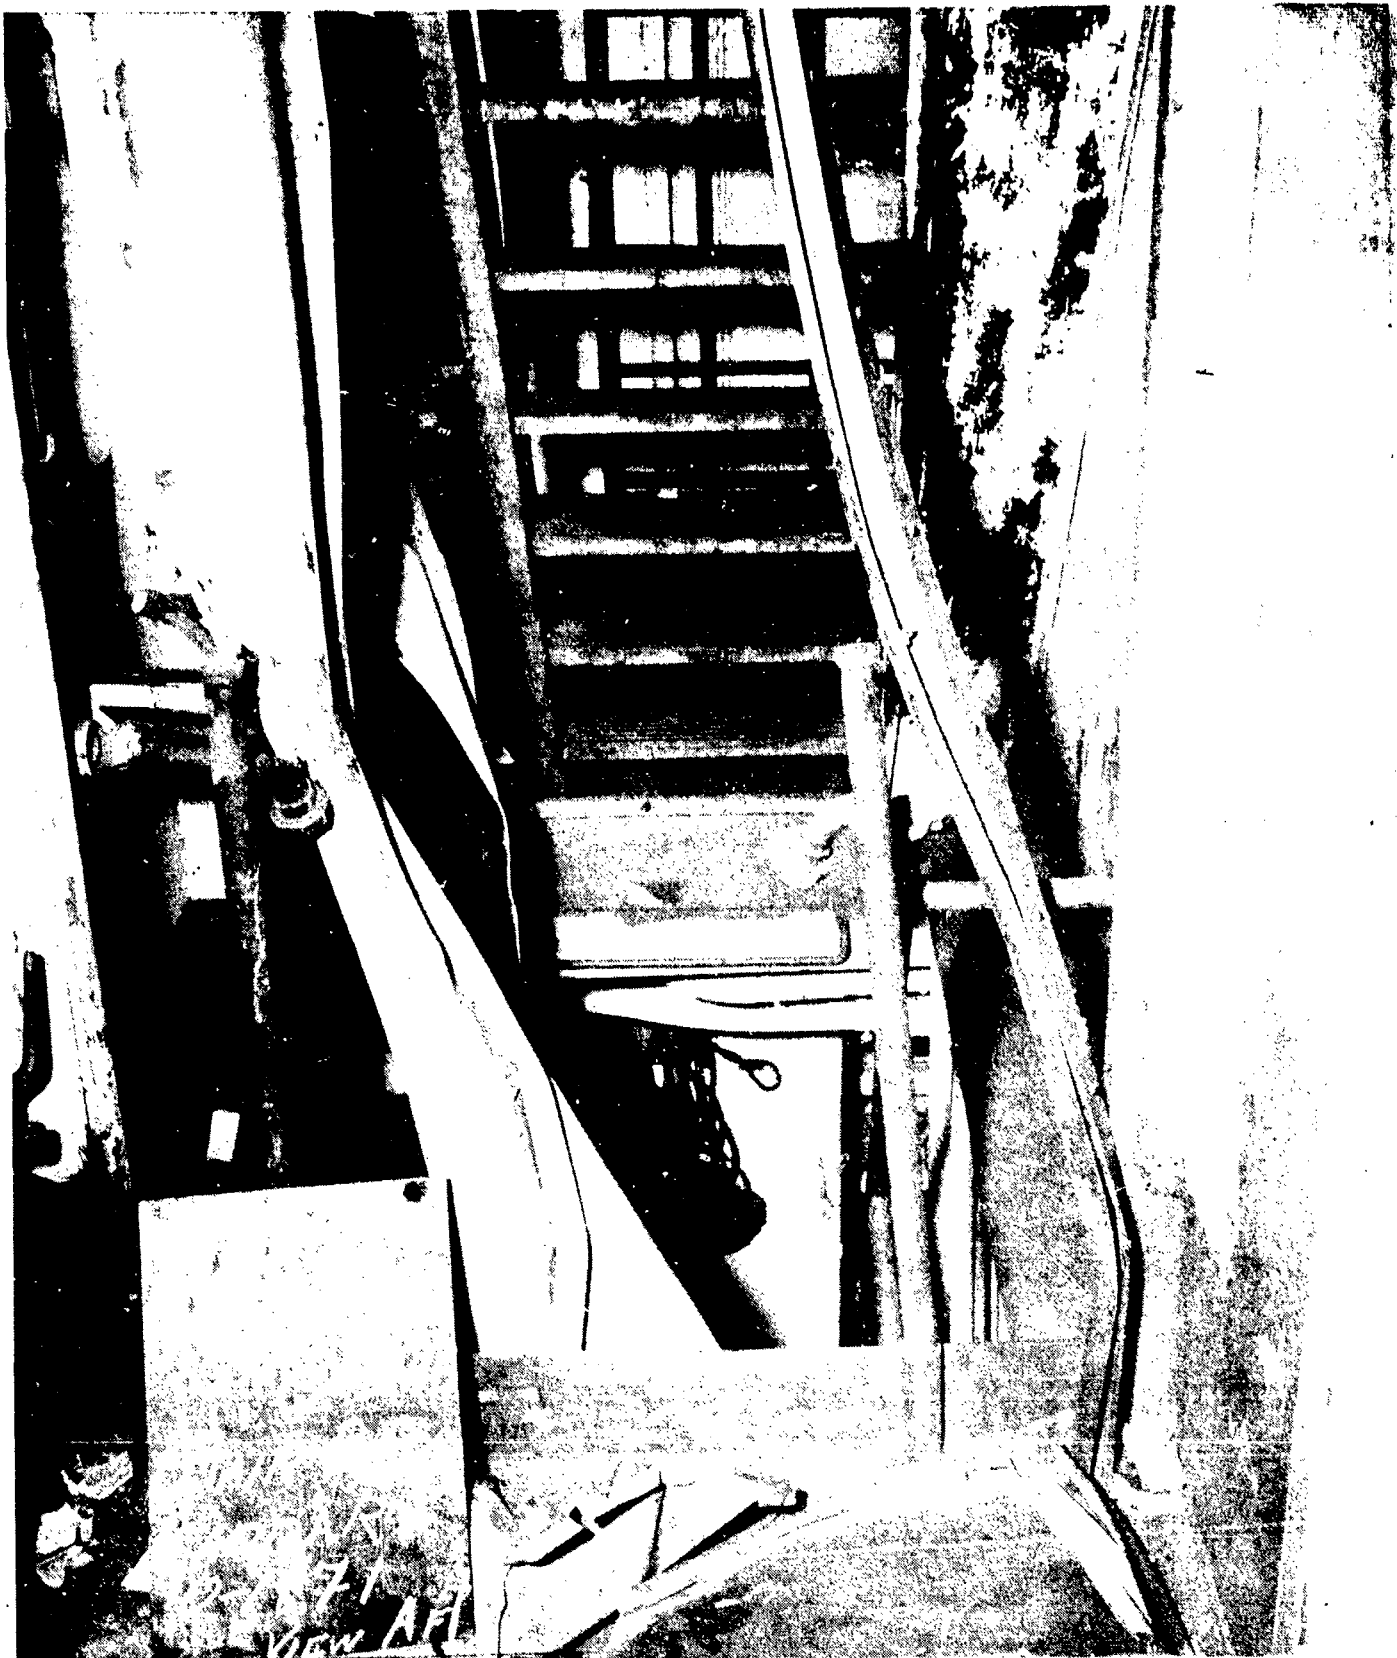
AA-CR-82-1828-12. Main deck, frame 87, starboard. Damage to metal joiner, light lock around ladder 1-87-1.

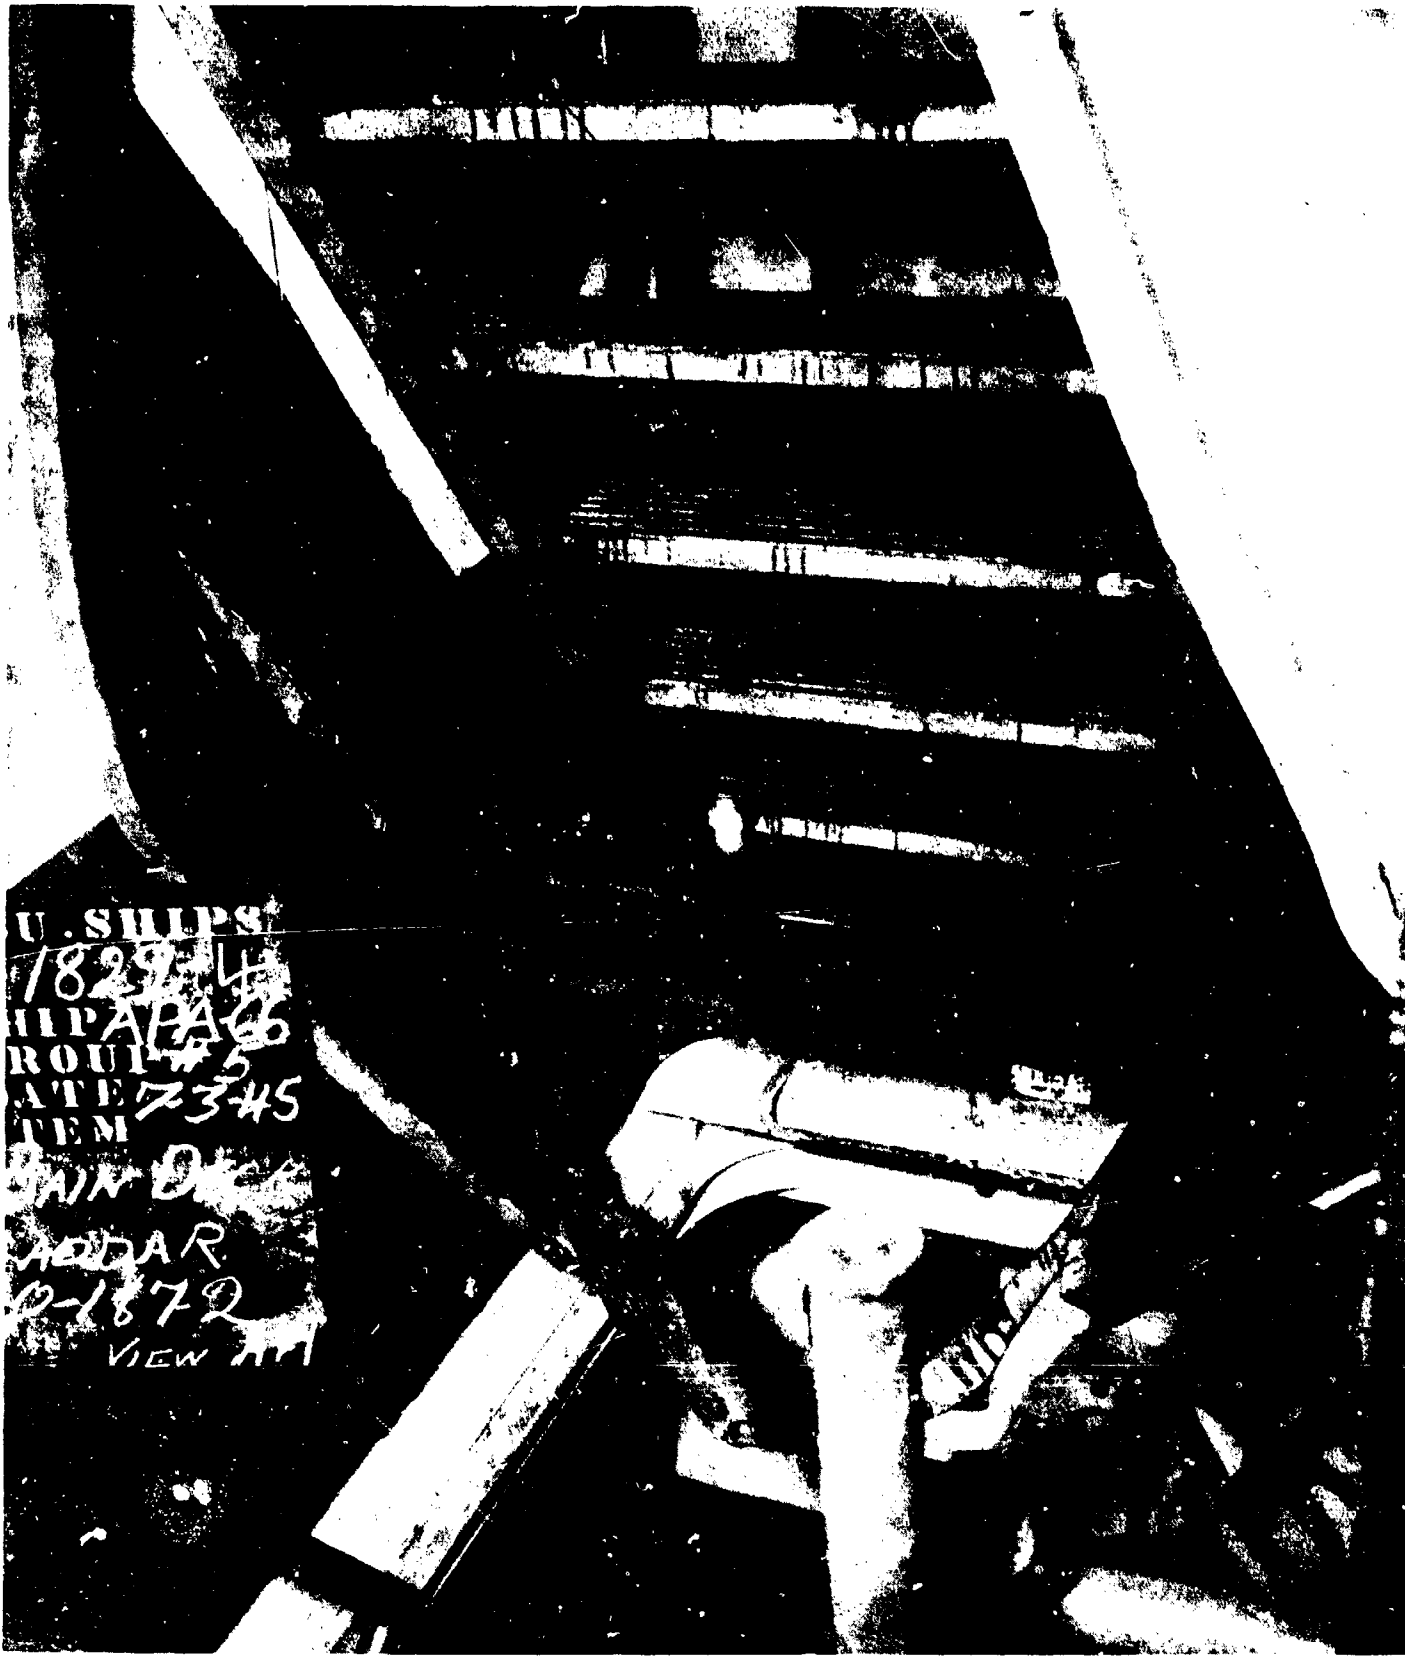
AA-CR-82-1829-4. Main deck, frame 87, port. Damage to metal joiner light lock around ladder 1-87-2.

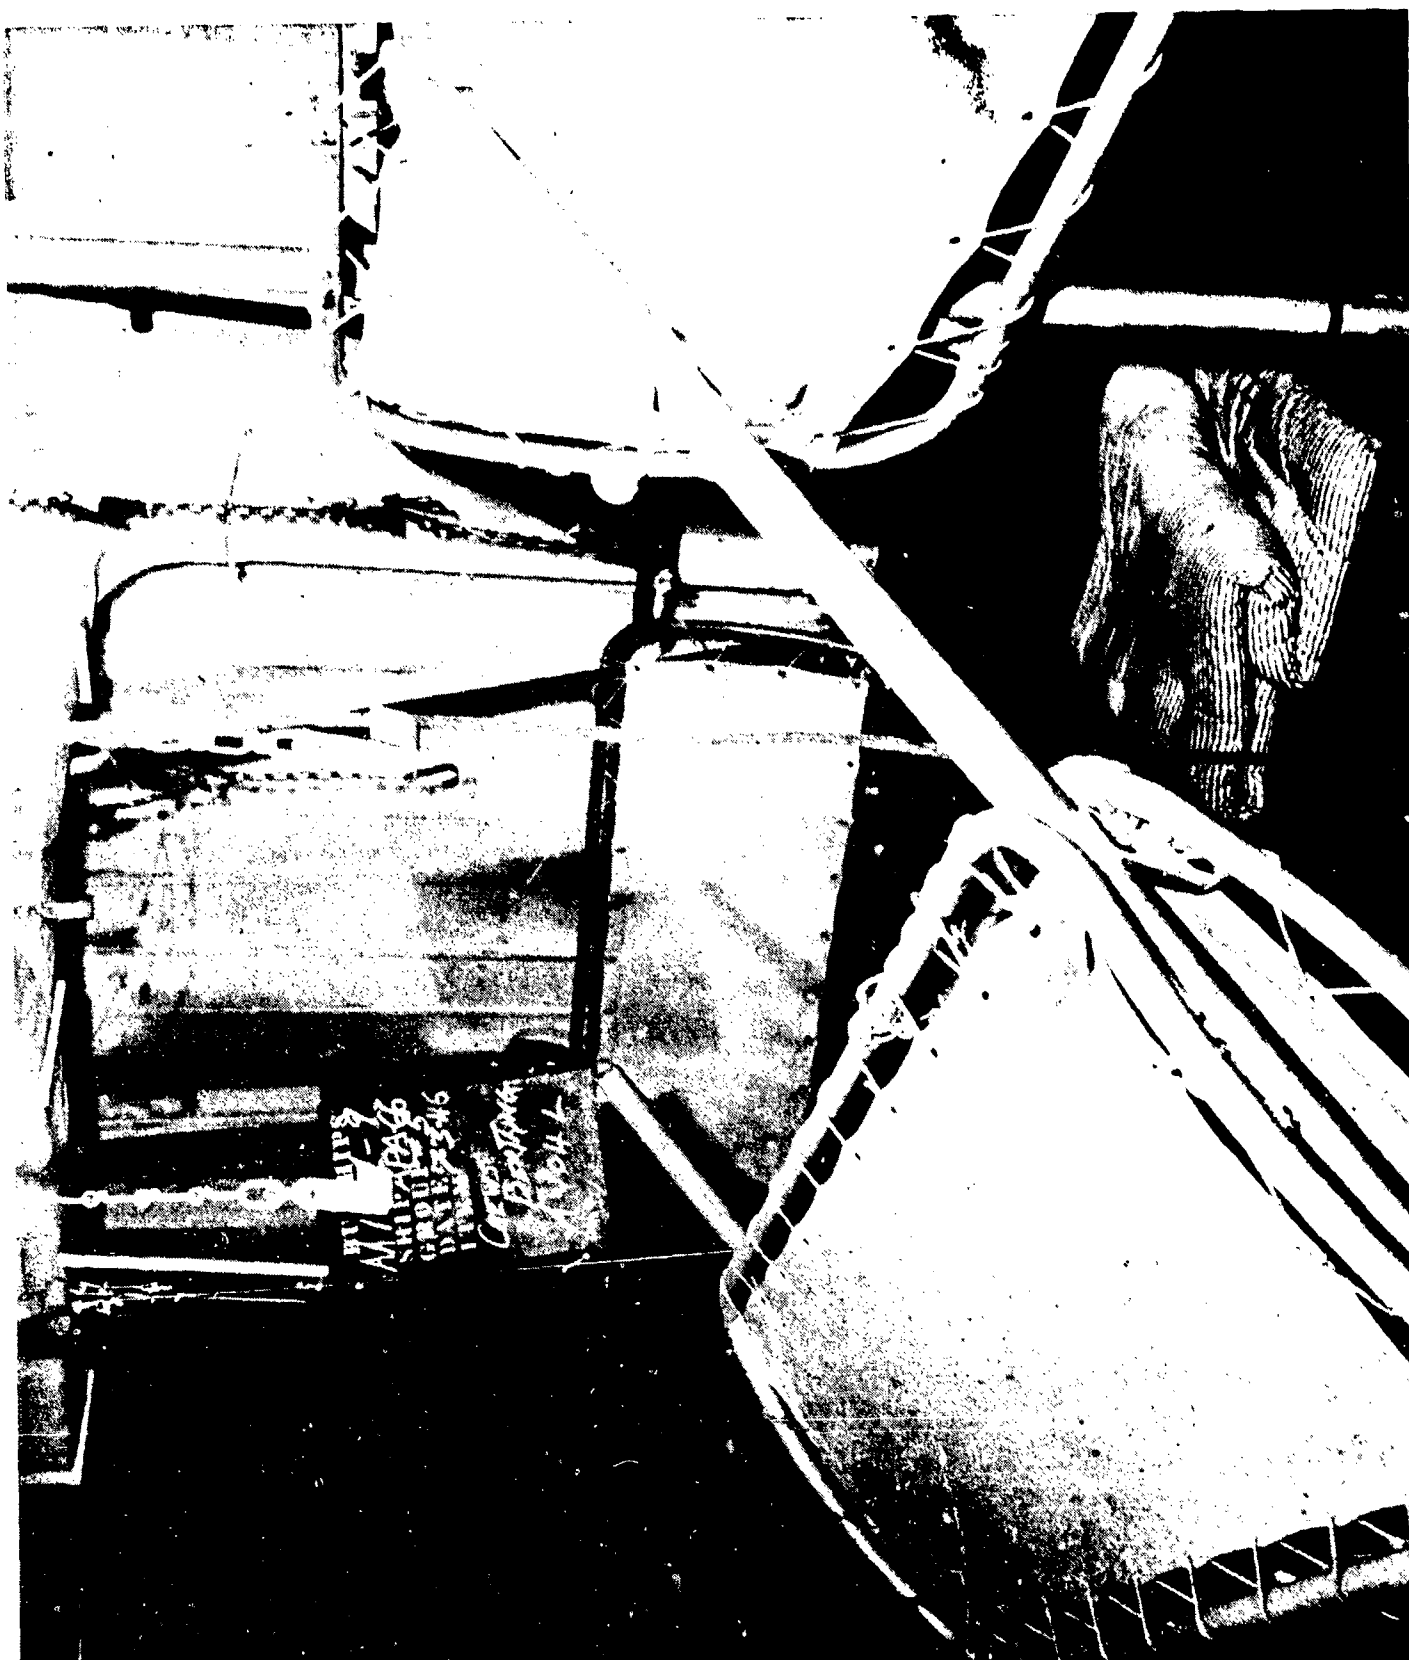
AA-CR-82-1827-9. A-104L. Disarrangement of bunk stanchions and bunks.

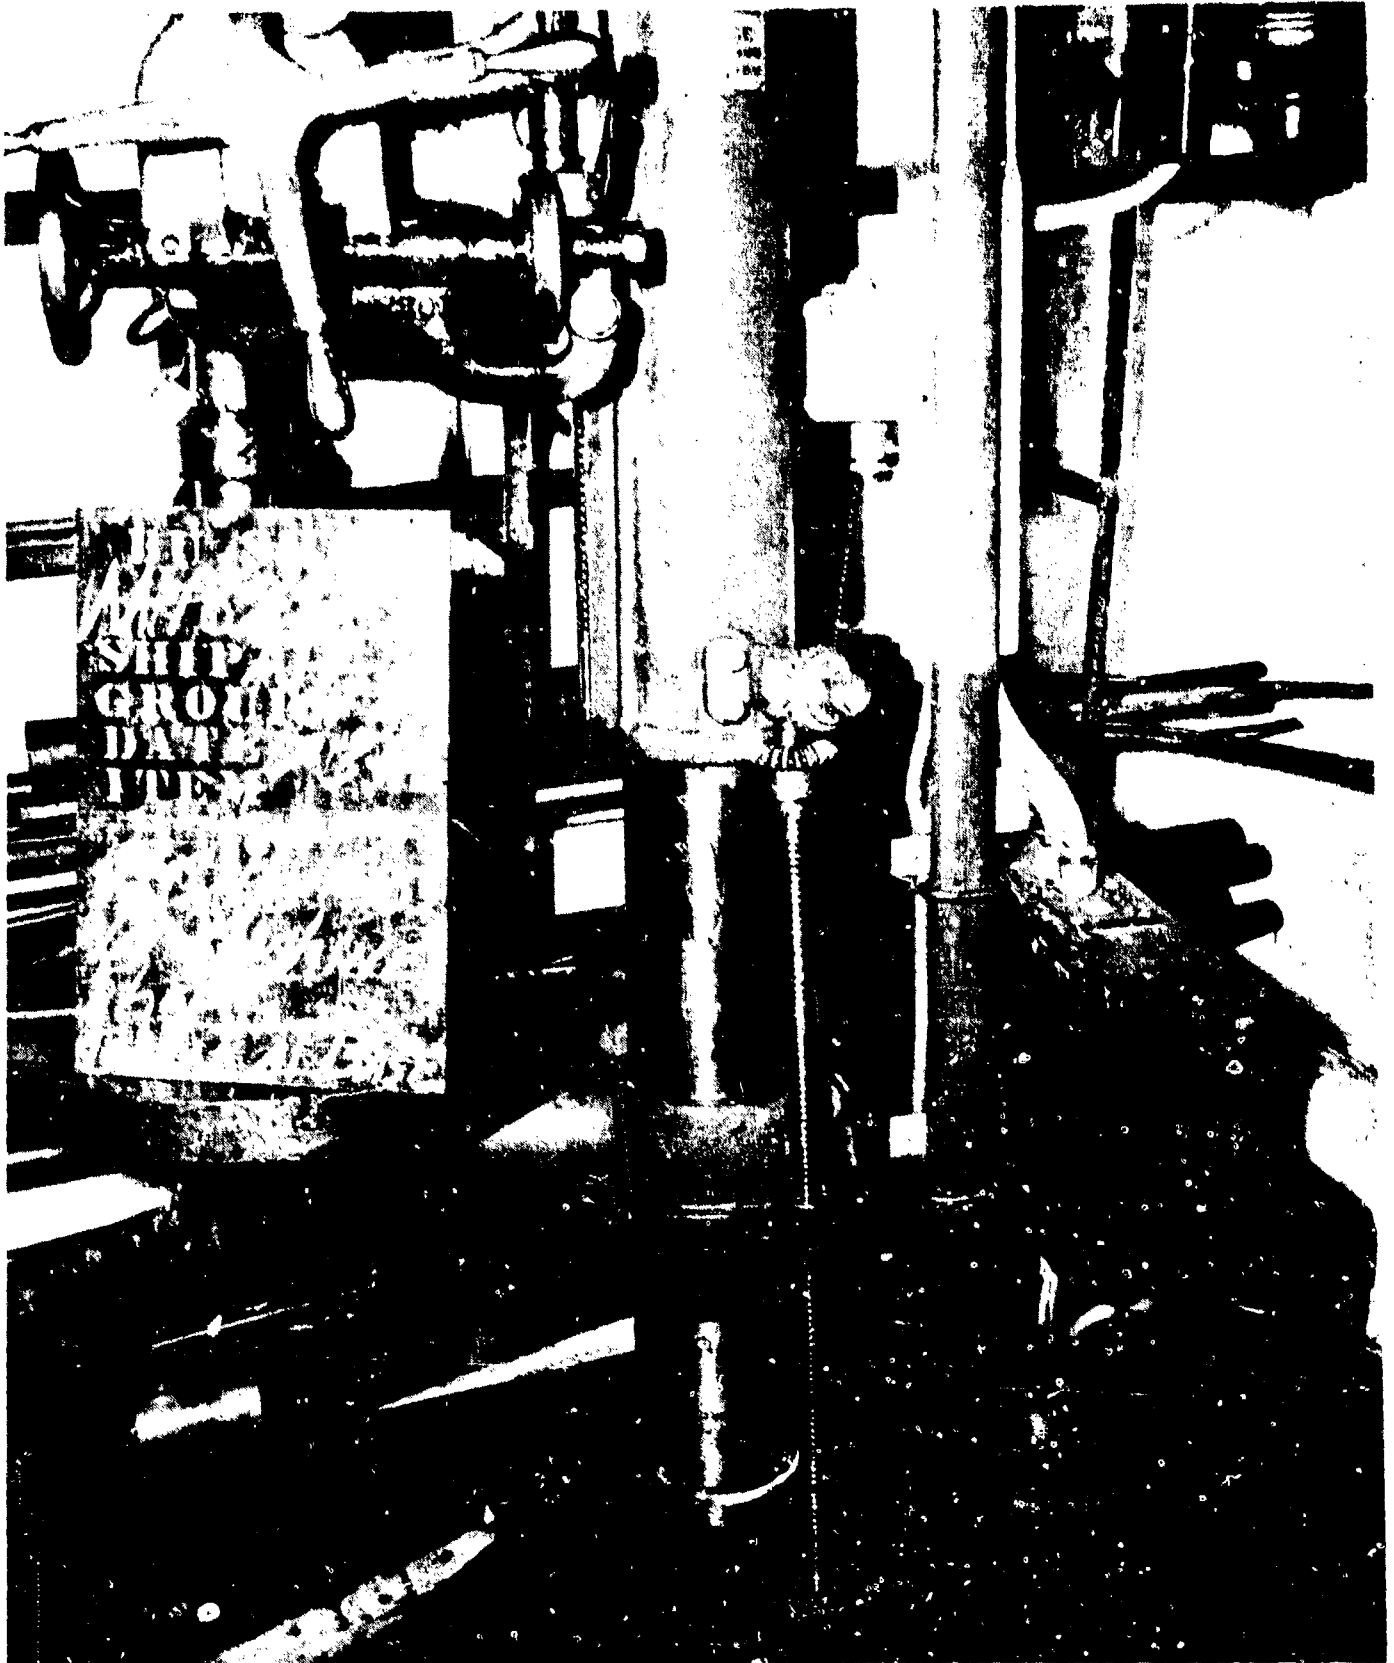
Shock damage is slight. A drill press pedestal in the machine shop is broken near the deck. Shock caused an oil ring to jump out of a bearing in number one ship's service generator. Gyro repeaters on both wings of the navigating bridge were knocked off their pedestals. A gyro repeater on the signal bridge level was adrift from its trunnions. Shock, or blast pressure, caused breakage of small salt water pipes in heads and showers. This piping was already badly corroded.

AA-CR-82-1828-5. Fractured pedestal of drill press in machine shop.

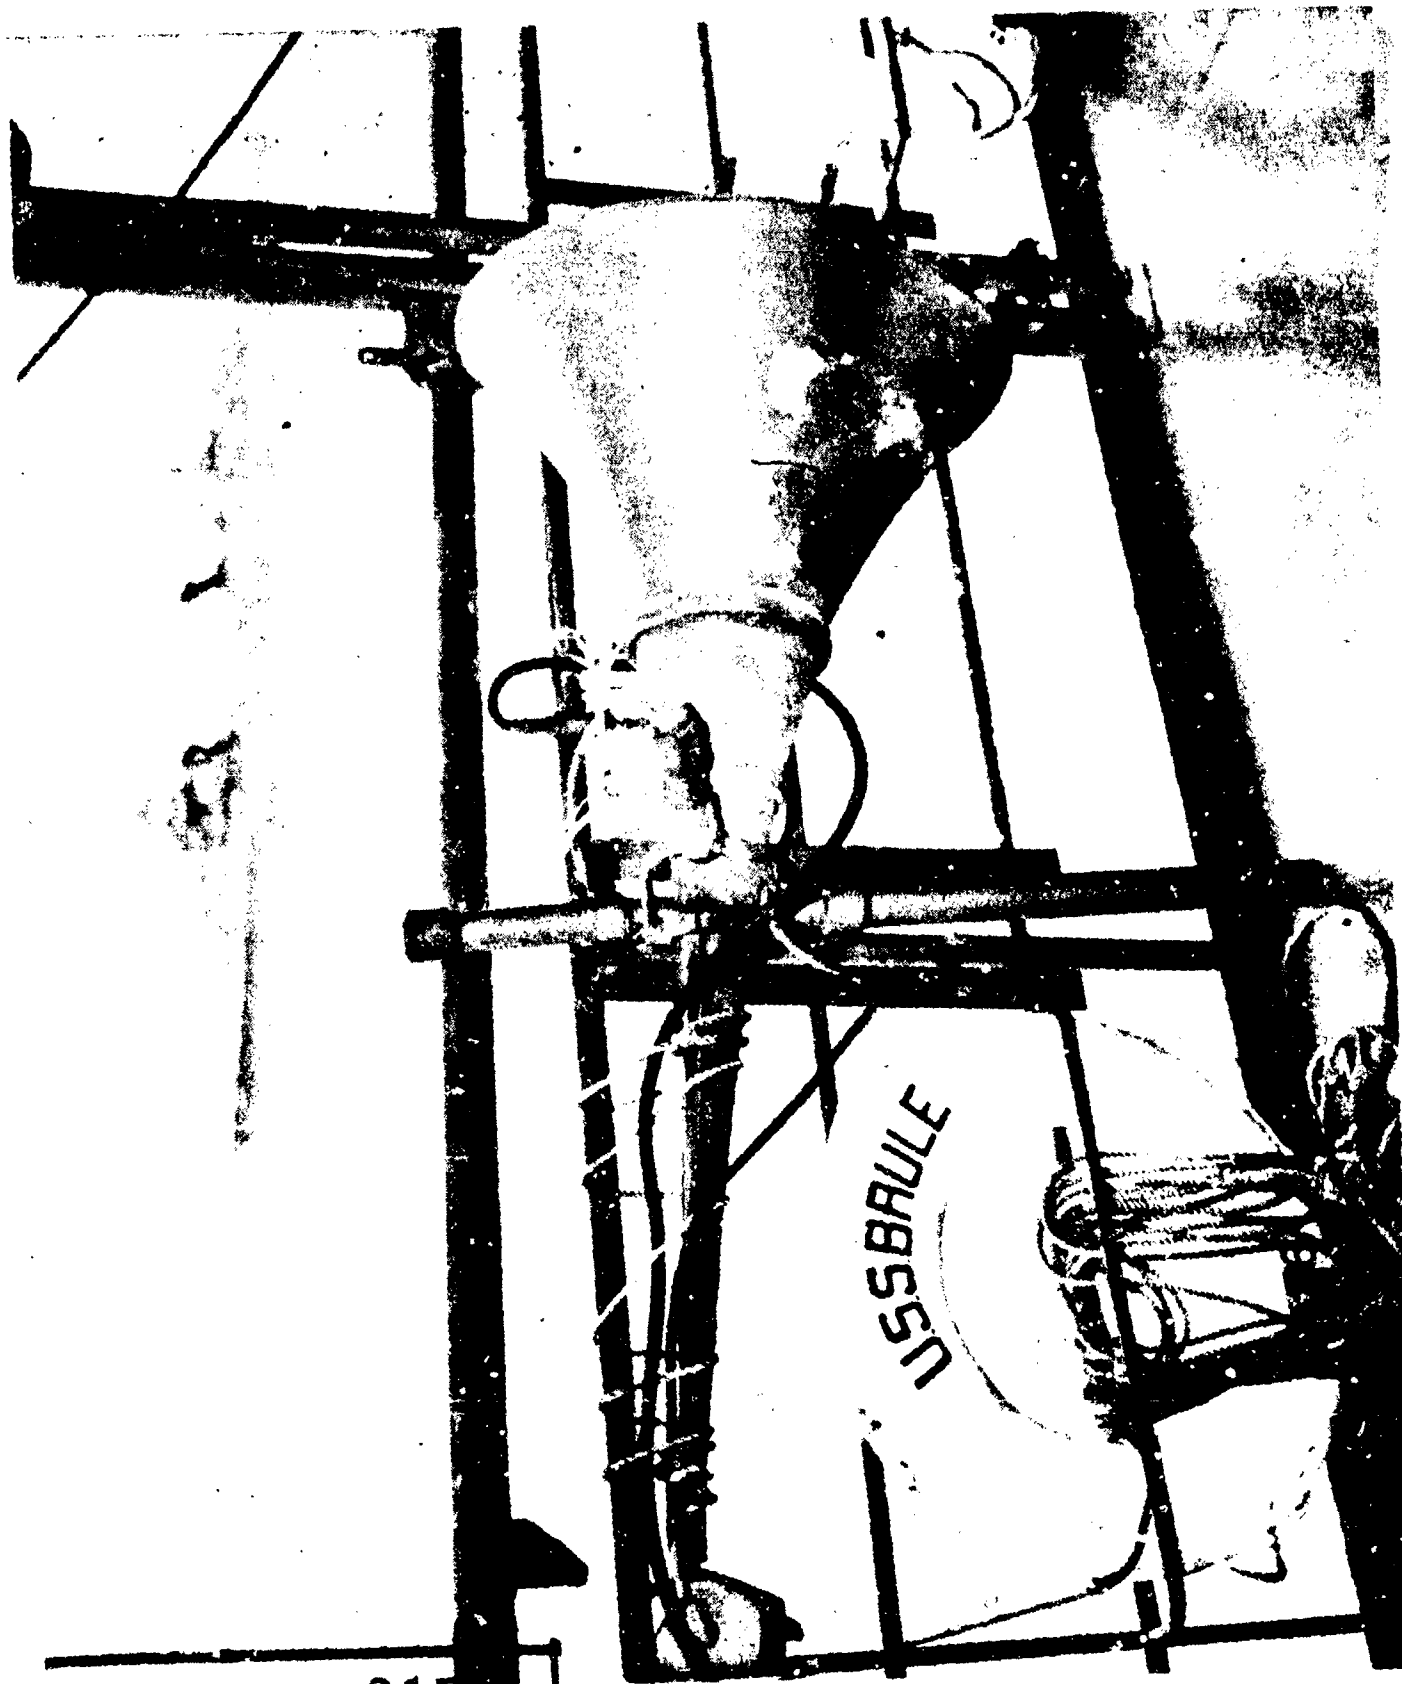
AA-CR-175-2157-5. Air blast bull horn Photo shows horn broken.  
from pedestal.
